Prepared for: The City of Everett Public Works

08.18.17

# Maple Heights Bridge Structural Memo

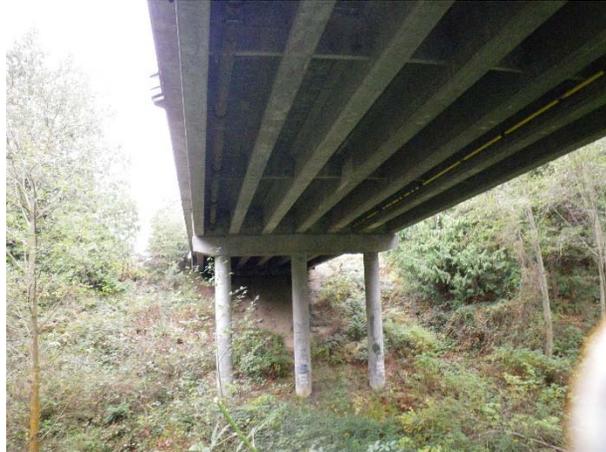
From this investigation, it has been determined that the bridge is at risk of collapse during a large seismic event. The critical locations are the abutments. A nonlinear static pushover analysis was performed and no failure mechanisms were formed from lateral forces exerted to the bridge during a design earthquake event. It was also found that the bridge has adequate superstructure strength and column shear strength.

Per the results obtained from this study, the original construction cost estimate submitted for funding has been reduced to provide the required girder seat length at the east abutment, adding transverse shear keys at both abutments, and investigating possible soil failure mechanisms.
