BIOLOGICAL EVALUATION

SOUNDVIEW BUSINESS CAMPUS **EVERETT, WA**

Wetland Resources, Inc. Project #14109

US Army Corps of Engineers Reference Number: NWS-2014-838

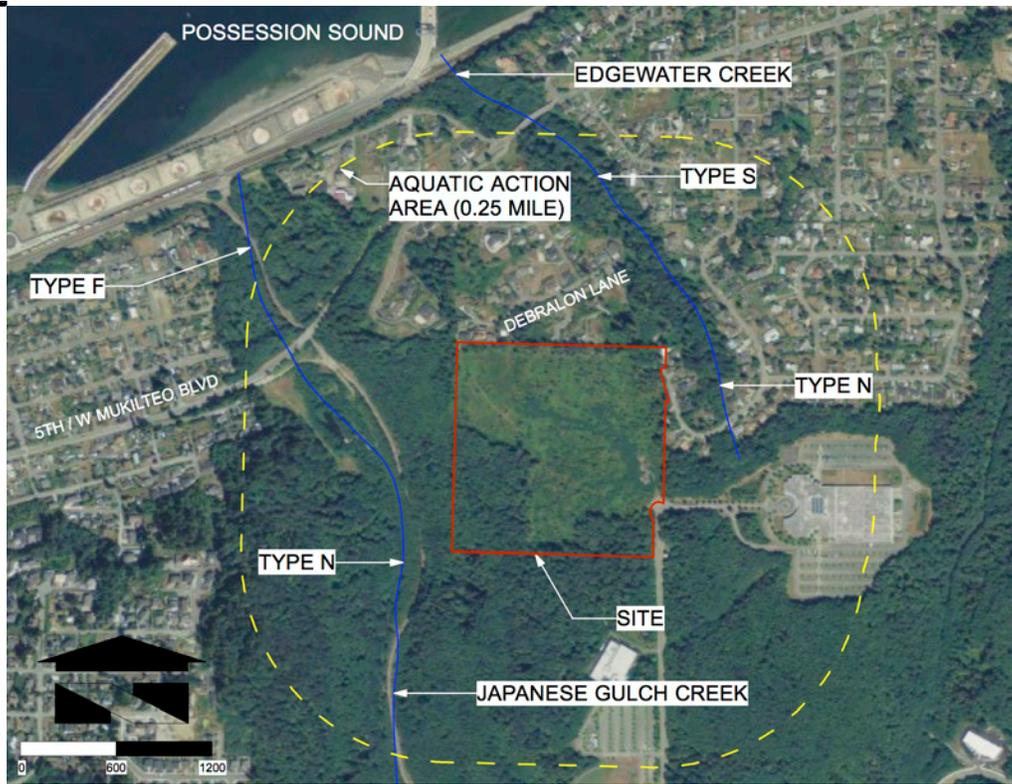
Figure 2: Aquatic Action Area Soundview Business Center.

The proposed action includes wetland impacts for the proposed development. The terrestrial action area includes all suitable habitats for a radius of one mile from the project site. The aquatic action area includes the on-site wetlands and adjacent areas within one-quarter mile.

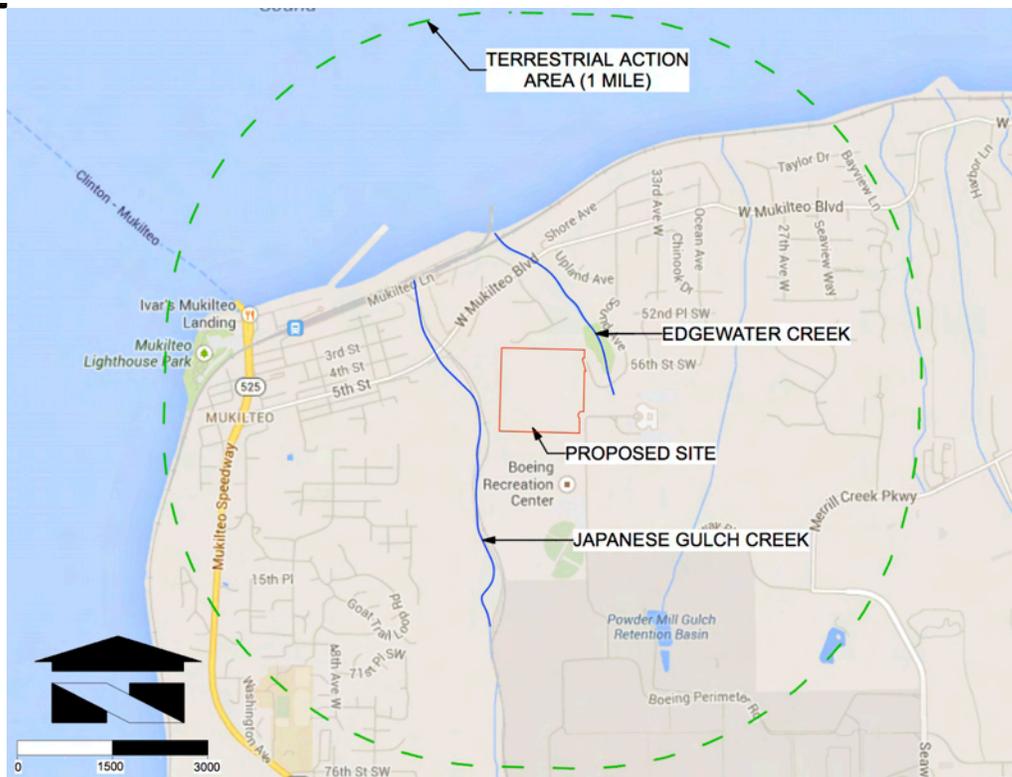
Figure 3: Terrestrial Action Area for Soundview Business Center.

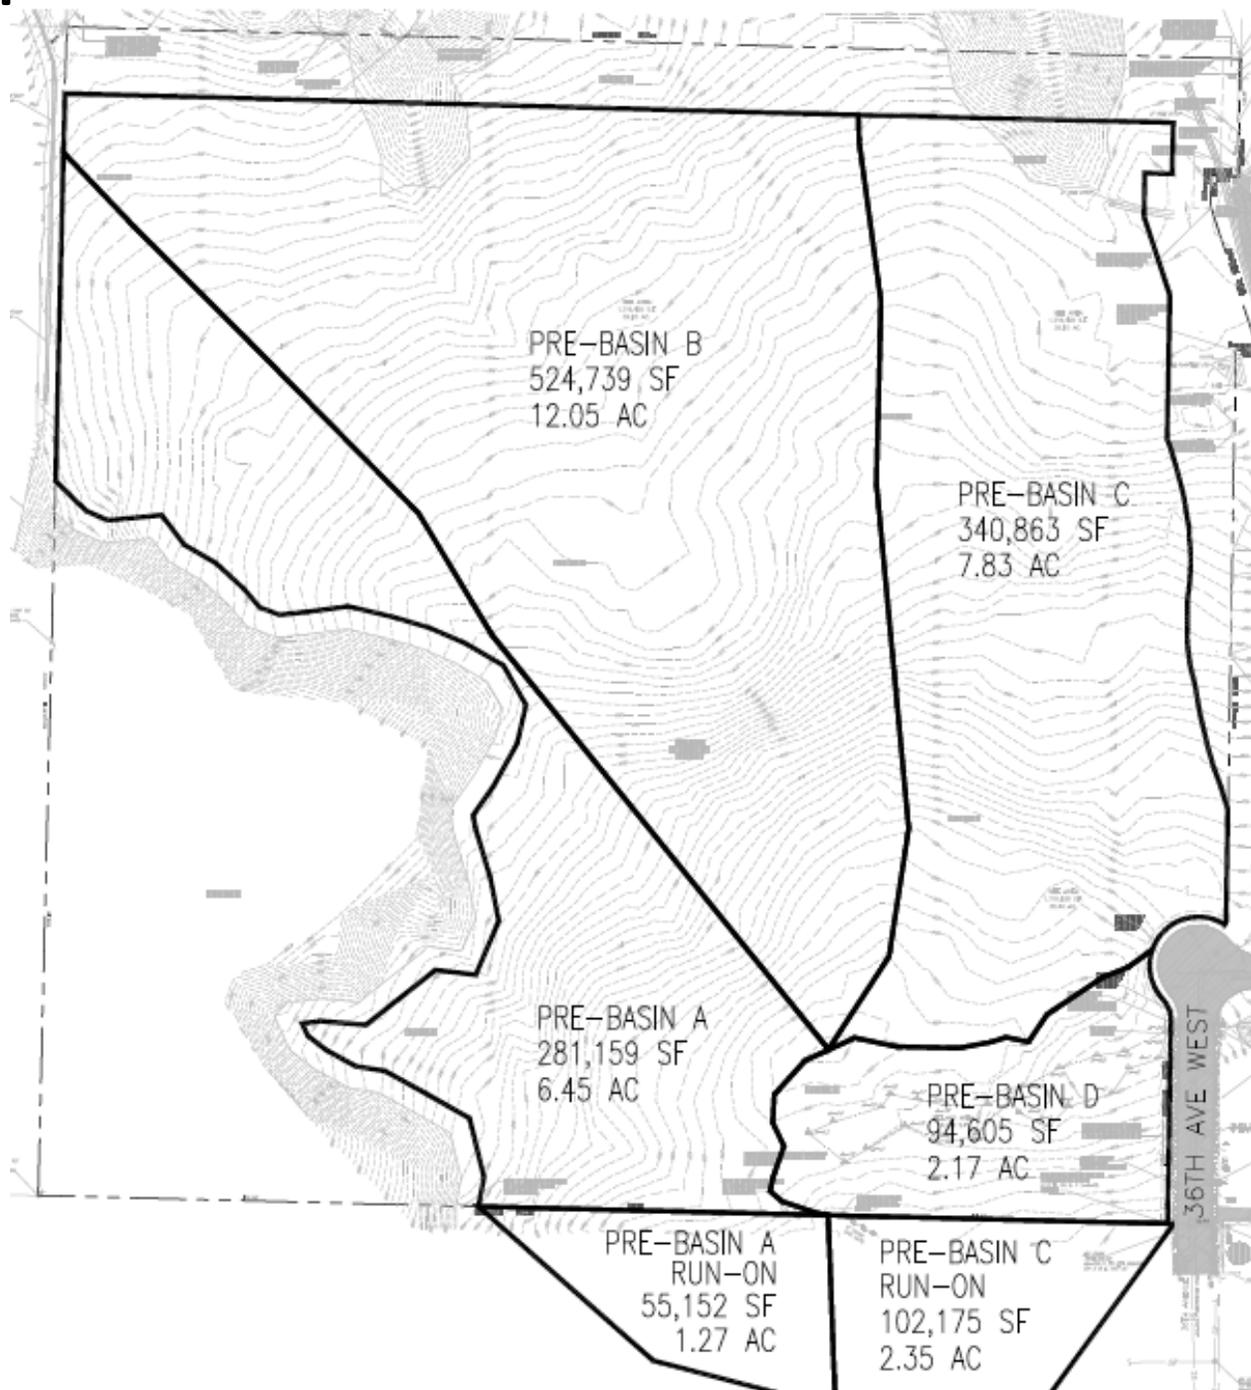
Figure 3: Drainage basins on the proposed development site for Soundview Business Center.

There are currently four drainage areas existing onsite, as shown in Figure 4. The western-most portion of the site to be developed (Pre-Basin A) drains the western portion of the site down to Japanese Gulch Creek. The northwestern drainage area (Pre-Basin B) drains north into an intersecting ravine which leads into a series of existing stormwater conveyance features that eventually discharge into the ravine above Edgewater Creek. The northeastern drainage area (Pre-Basin C) drains to the northeast into a ravine that shallows out and is intersected by a drainage ditch leading into Edgewater Creek. The southeastern drainage area (Pre-Basin D) contains Wetlands A-C, and is hydrologically sourced from the off-site area to the south (Pre-Basin C Run-On). Runoff currently outlets from Wetland A into a catch basin, under 36th Avenue West via a culvert that flows to an existing stormwater conveyance ditch on the neighboring property.

Under developed conditions, stormwater from impervious surfaces on the site will be directed to on-site stormwater vaults located on the western and northern edges of the developed areas. Stormwater will be treated for water quality prior to detention via underground vaults. Clean stormwater will exit the site through a controlled release system. Stormwater will be released to the west, north, and northeast (Pre-Basins A, B, and C respectively) in proportions that will mimic the current drainage regimes within the site. Drainage released to Pre-Basin A will be

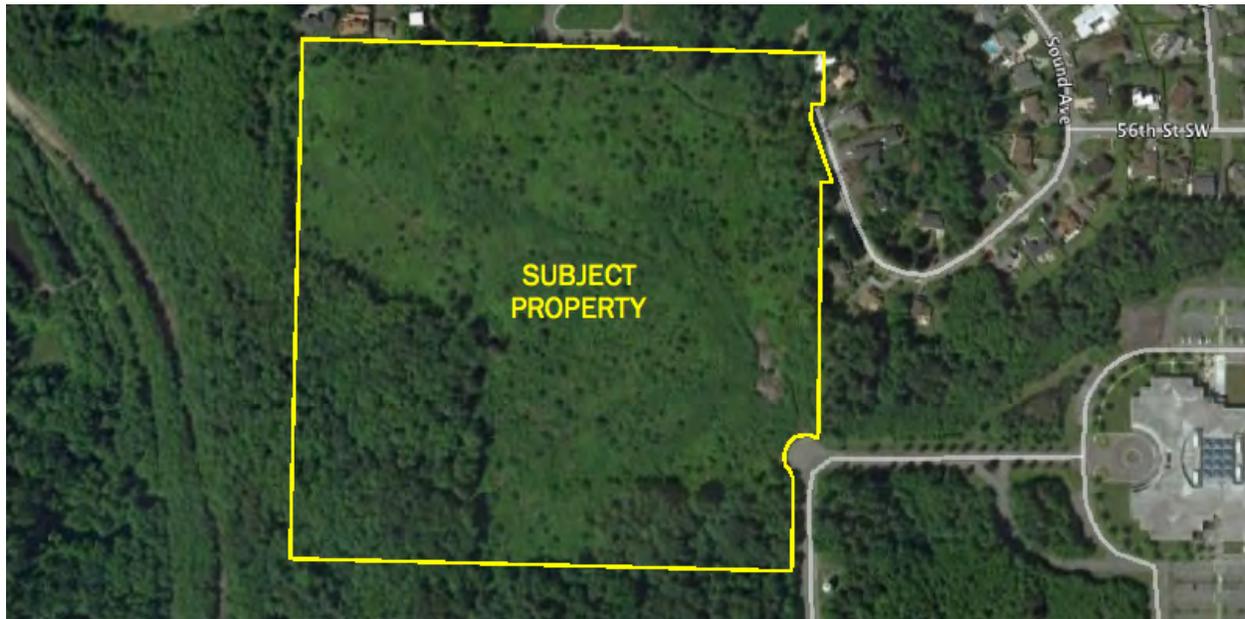
Figure 1: Current aerial view of the subject property.

With the exception of the forested area in the southwestern portion of the site, the subject property displays a general northern aspect. The southwestern portion of the site contains a steep west aspect slope associated with Japanese Gulch. The southeastern corner of the site drains to the east.

Surrounding land use is comprised of a commercial development to the east (*Intermec Corp.*), residential development to the north and northeast, and forested areas to the west and south. The Boeing railroad spur lies just west of the site in Japanese Gulch. Current zoning of the site is M-1 Office and Industrial Park.

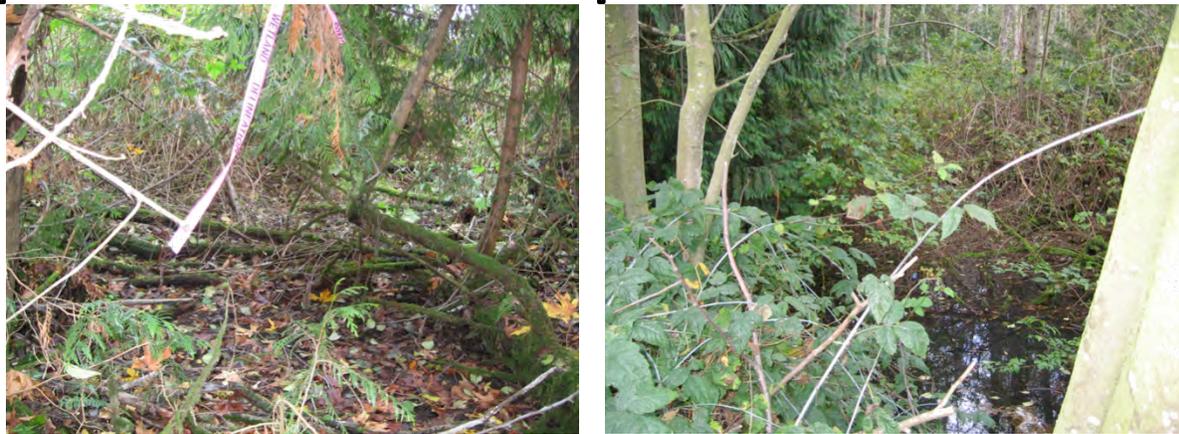
Figures 1 & 2: Views of Wetland A

Wetland A is located in the Southeastern portion of the subject property. Wetland A is a depressional wetland with a highly constricted outlet. Forested vegetation dominates Wetland A. This wetland is part of a wetland mosaic existing in the southeastern corner of the site. The primary source of hydrology to the wetland complex is surface flows from the south.

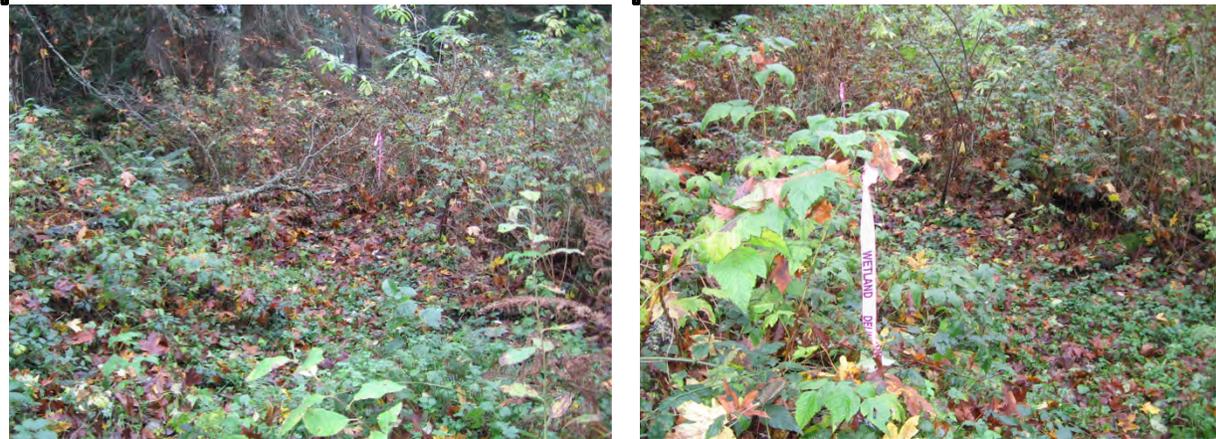
Figures 3 & 4: Views of Wetland B

Wetland B is located in the Southeastern portion of the subject property. Wetland B is a depressional wetland with no outlet. It is primarily dominated by a forested vegetation community. This wetland is part of a wetland mosaic existing in the southeastern corner of the site. The primary source of hydrology to the wetland complex is surface flows from the south.

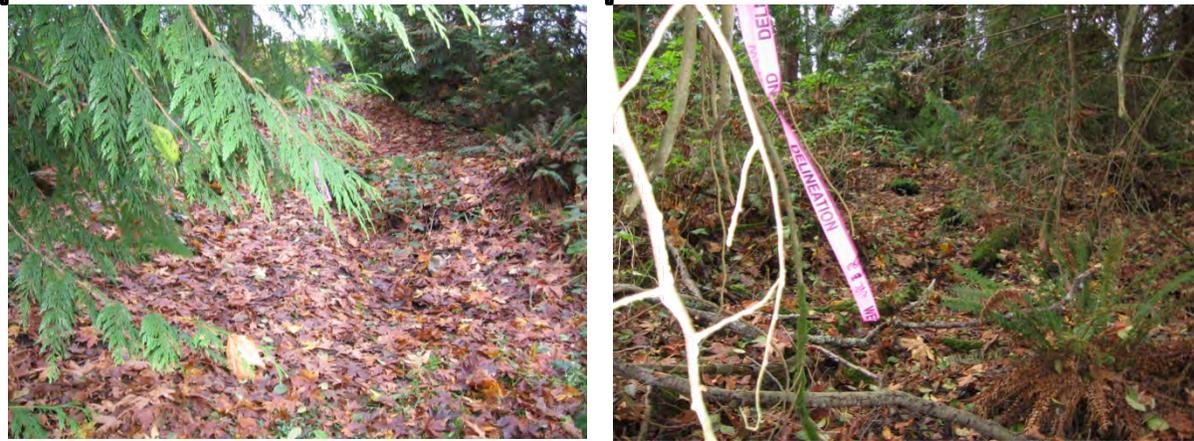
Figures 5 & 6: Views of Wetland C

Wetland C is located in the Southeastern portion of the subject property. Wetland C is a depressional wetland with no outlet. Forested vegetation dominates Wetland C. This wetland is part of a wetland mosaic existing in the southeastern corner of the site. The primary source of hydrology to the wetland complex is surface flows from the south.

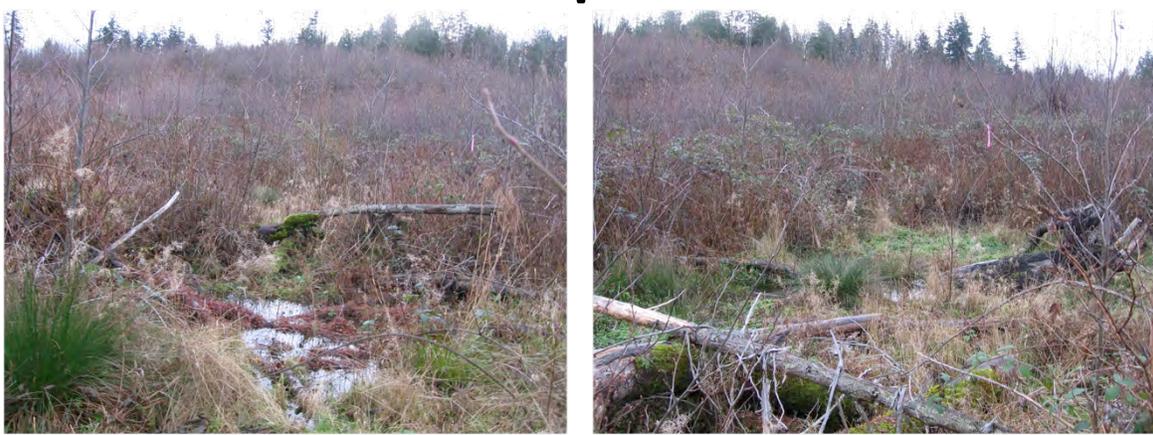
Figures 7 & 8: Views of Wetland D (2011)

Wetland D is located in the Southeastern portion of the subject property. Wetland D is a depressional wetland with no outlet. Forested vegetation dominates Wetland C. This wetland has been disturbed in the past and the vegetation is recently becoming reforested after significant clear-cutting events created highly disturbed conditions.

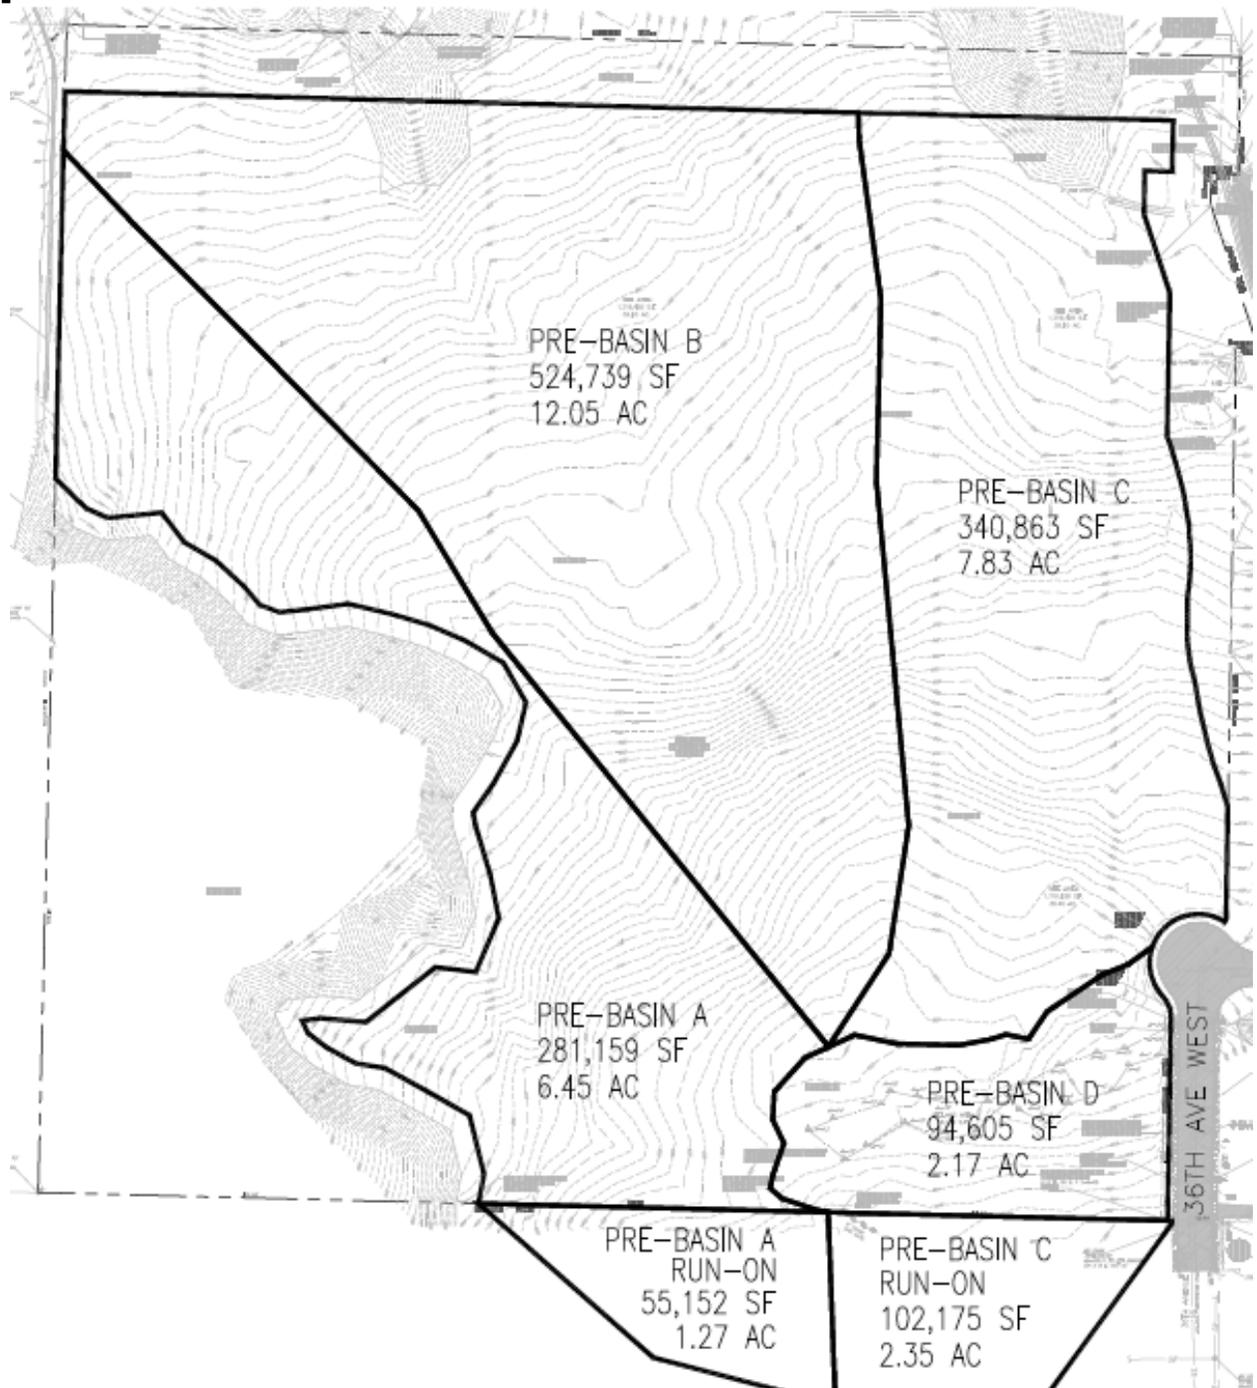
Figure 3: Drainage basins on the proposed development site.

There are currently four drainage areas existing onsite, as shown in Figure 3. The western-most portion of the site to be developed (Pre-Basin A) drains down the steep slope along the western border and in the southwestern corner of the site, and subsequently into Japanese Gulch. The northwestern drainage area (Pre-Basin B) drains north into an intersecting ravine, which leads into a series of several existing stormwater conveyance features that eventually discharge into the ravine above Edgewater Creek. The northeastern drainage area (Pre-Basin C) drains to the northeast into a ravine that shallows out and is intersected by a drainage ditch leading into Edgewater Creek. The southeastern drainage area (Pre-Basin D) contains Wetlands A-C, and is hydrologically sourced from the off-site area to the south (Pre-Basin C Run-On). Runoff currently outlets from Wetland A into a catch basin, under 36th Avenue W, flowing to an existing stormwater conveyance ditch on the neighboring property.

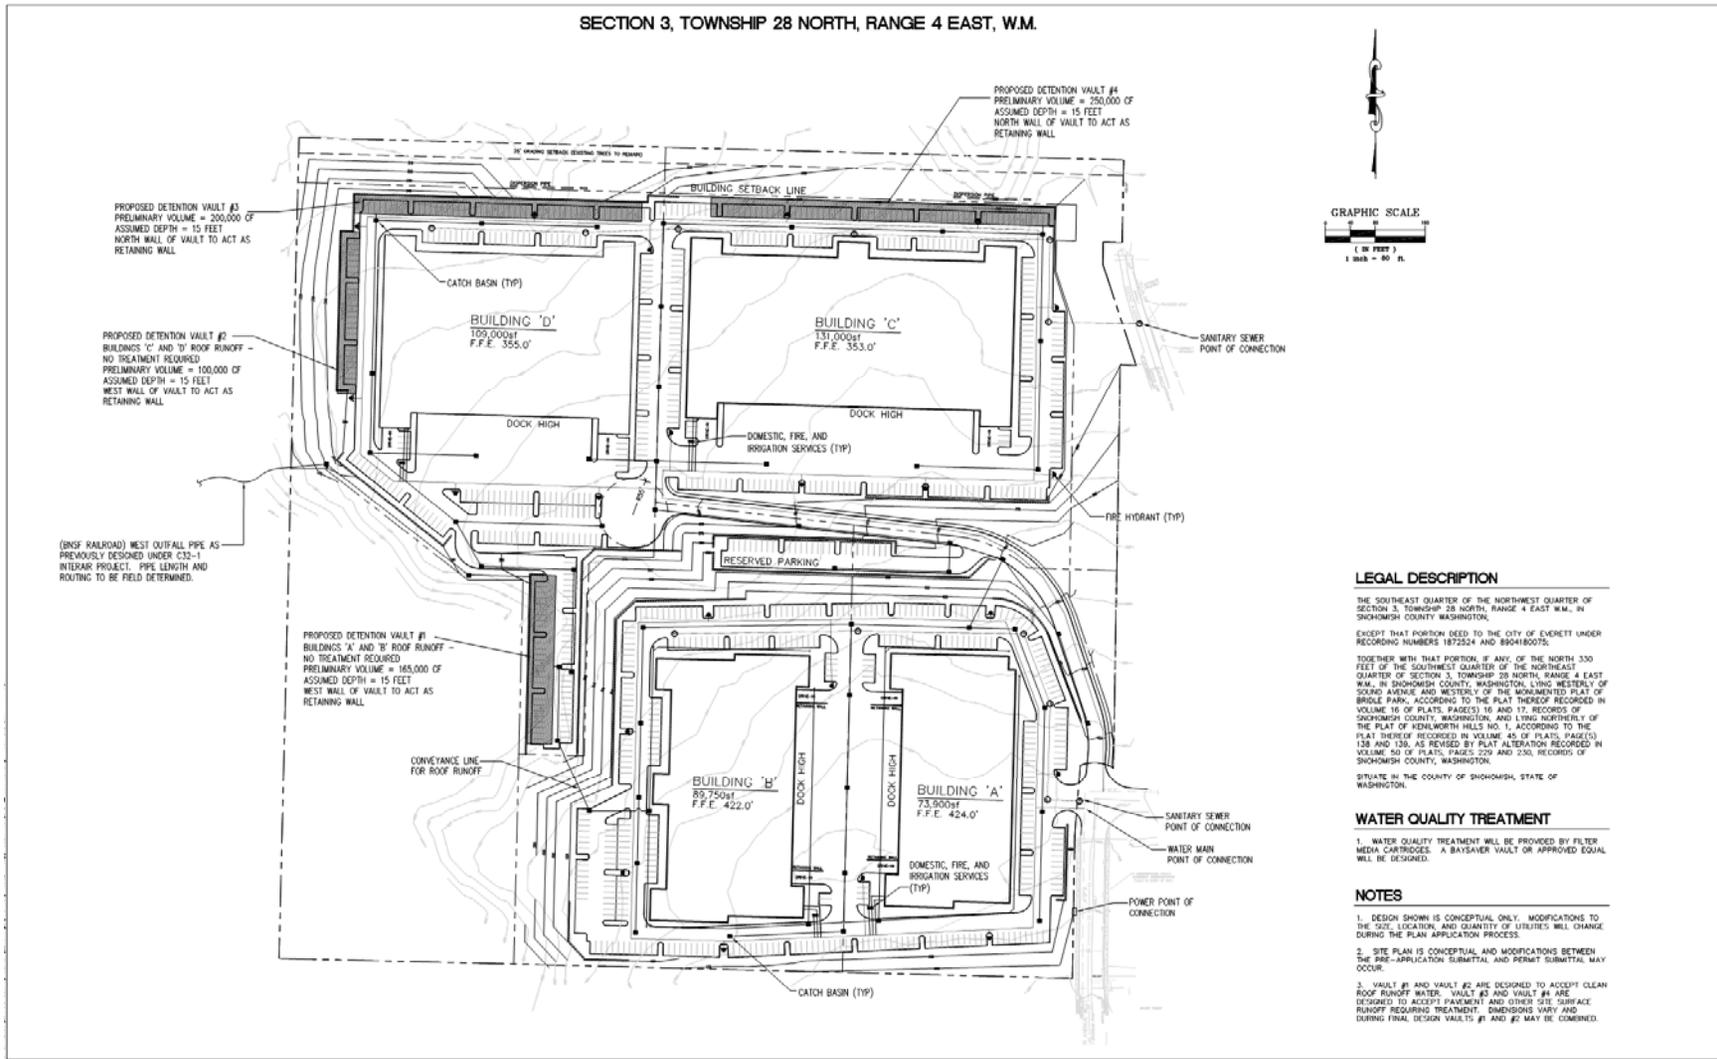
Figure 4. Proposed site development, plan view.

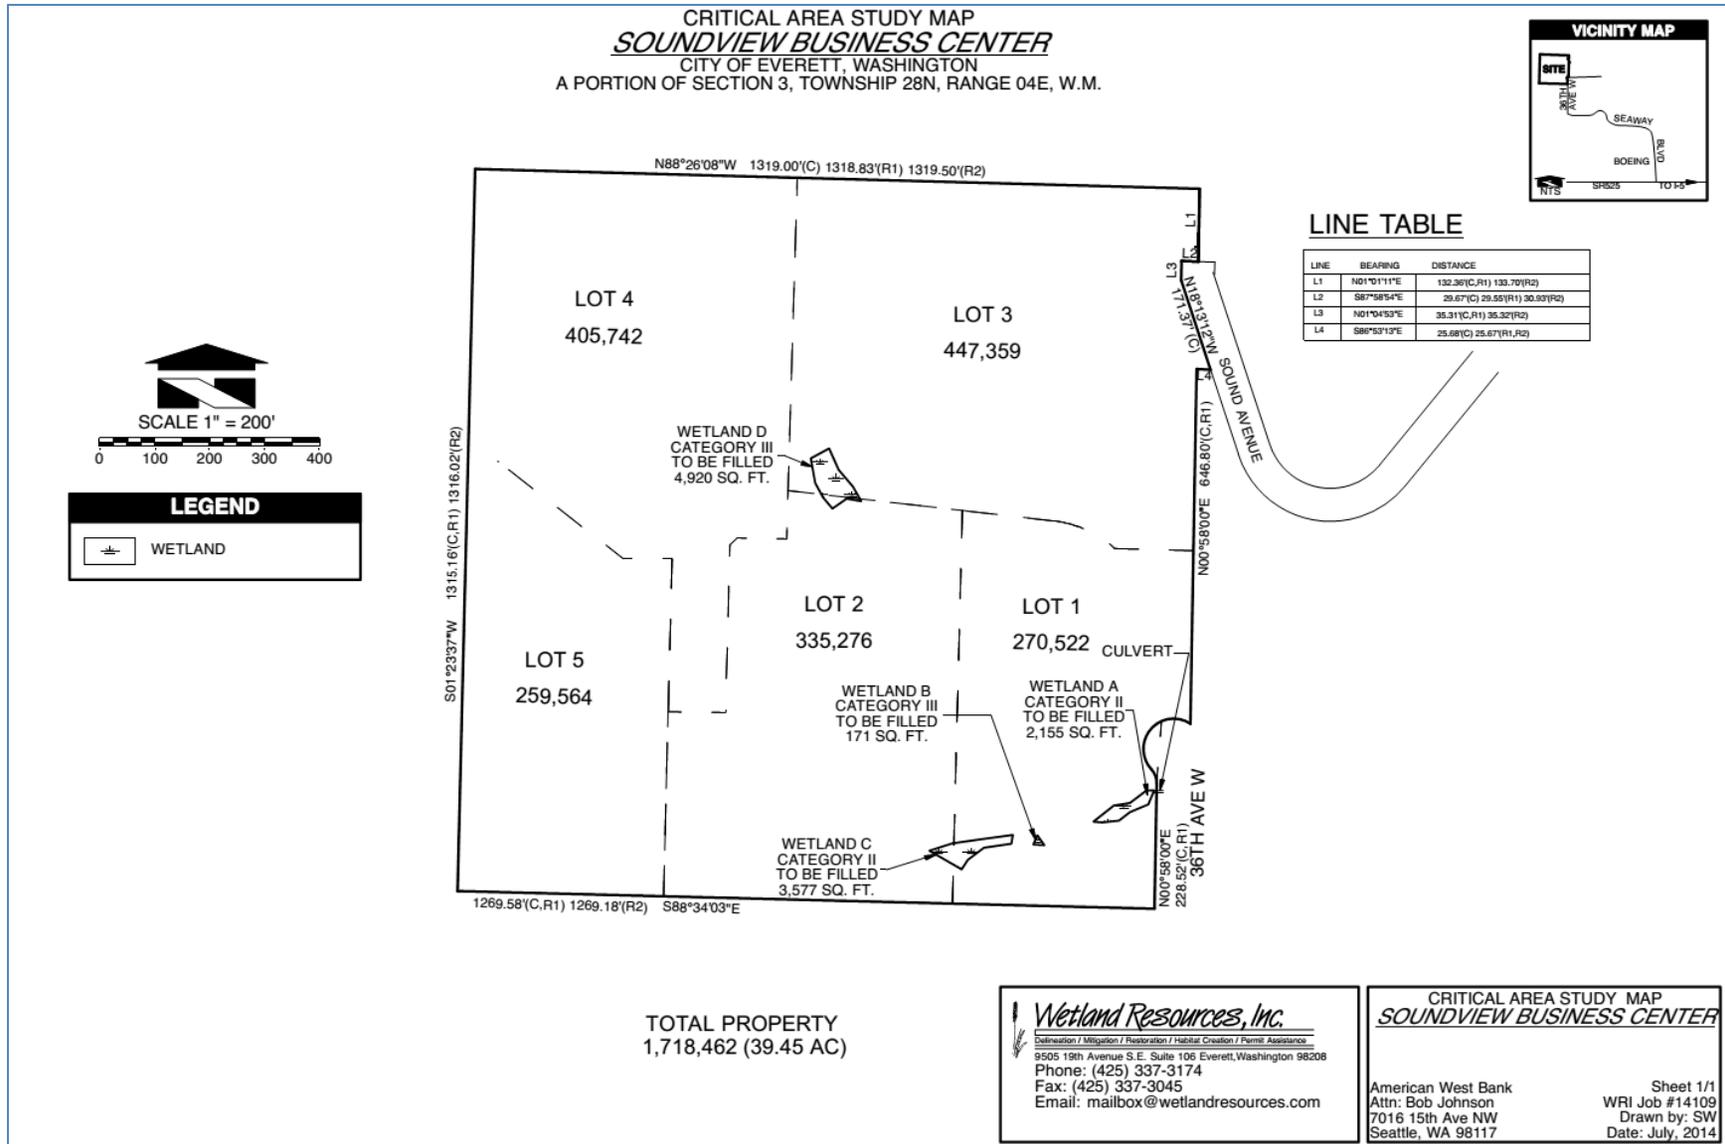
Figure 5. Portion of the proposed mitigation plans (image source: Wetland Resources, Inc.).

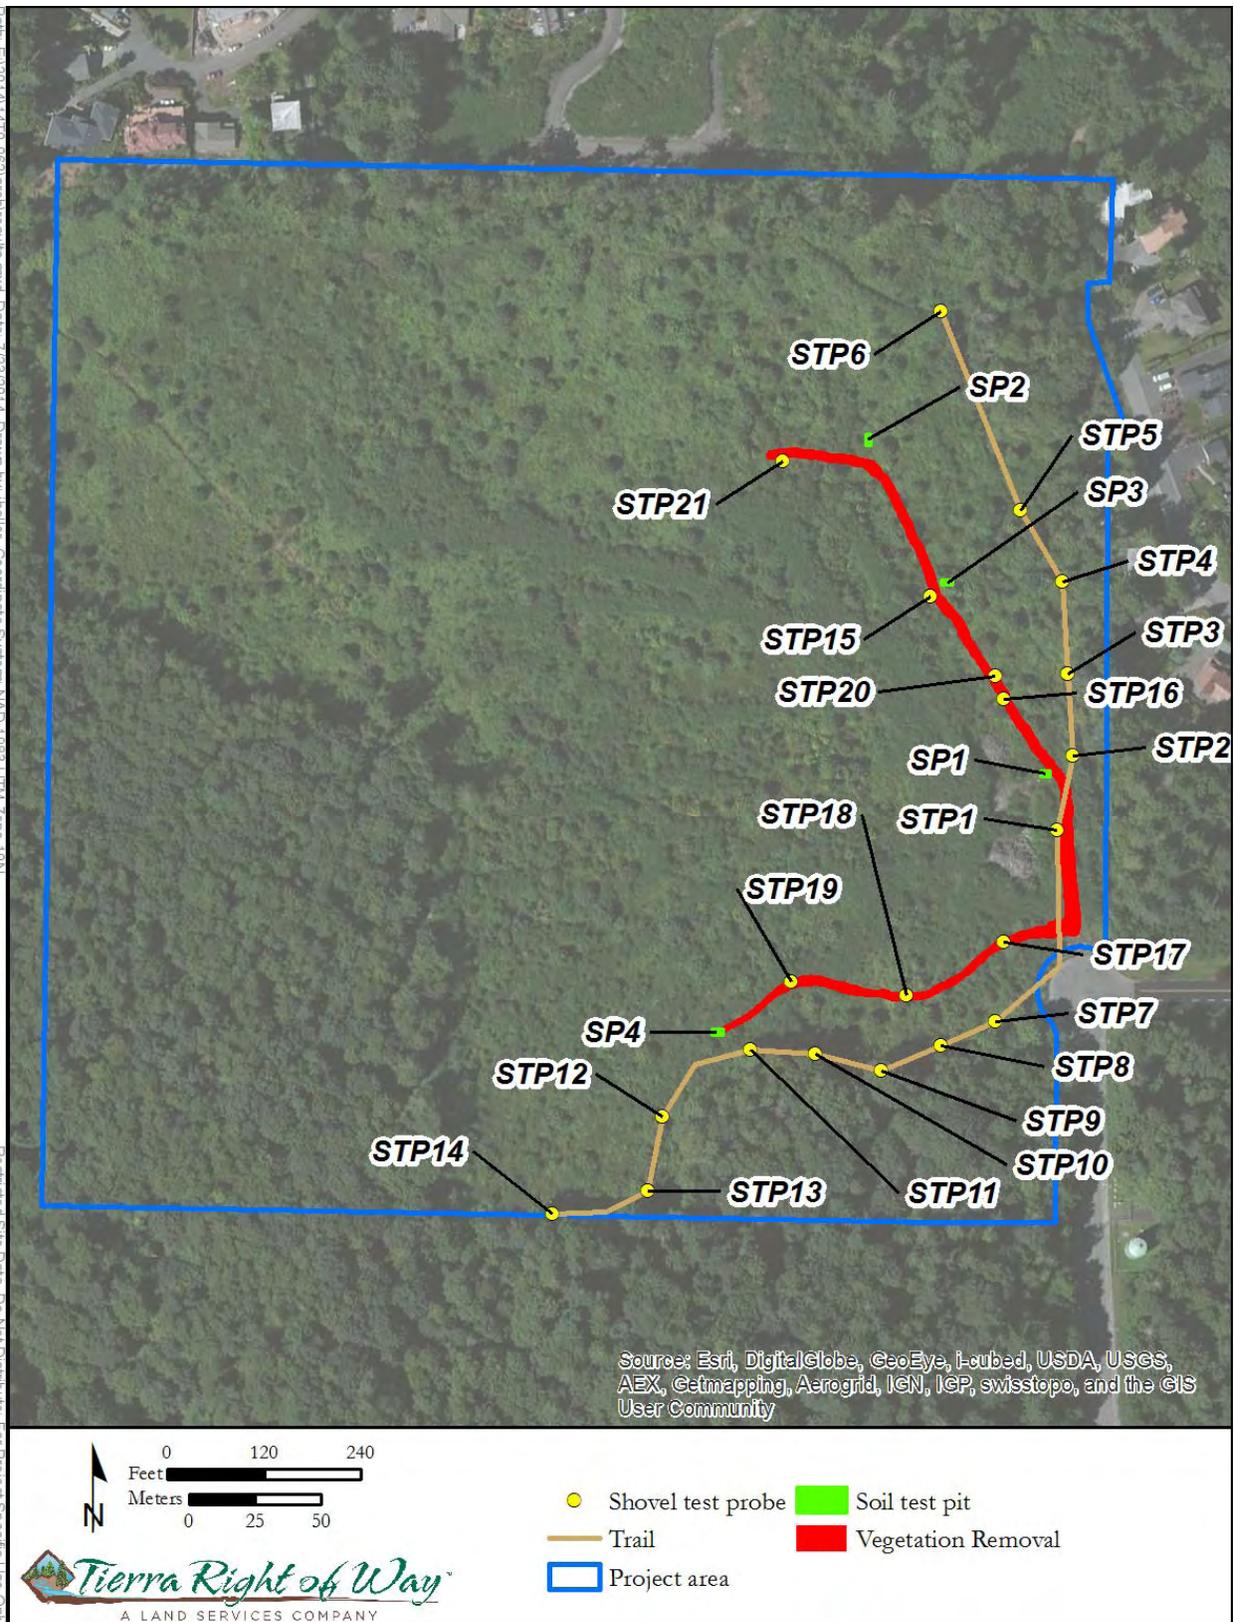
Figure 9. Detail of aerial image depicting the project APE and Shovel Test Probe (STP) and backhoe Shovel Pit (SP) locations (image source: Google Earth 2013).

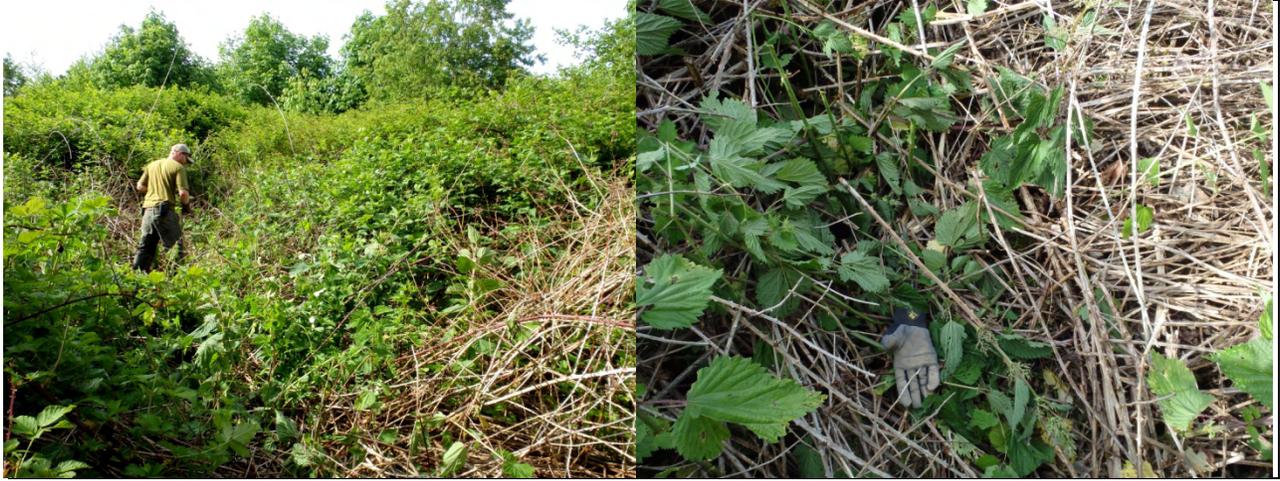
Photo 1. Dense blackberry growth seen throughout the site (left); surface visibility obstructed by dense blackberry growth (right).

pits extended only to the area indicated in Figure 9 and the overgrowth was otherwise impenetrable (Photo 1).

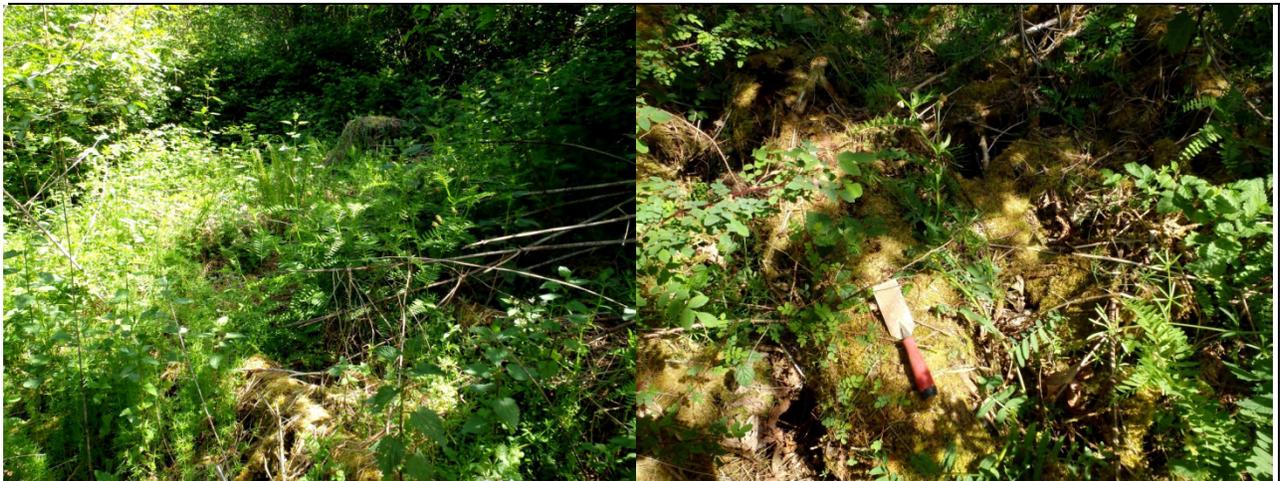
Photo 2. View of the undergrowth evidence of logging just north of the trail along the south border of the site: stumps and moss-covered logs (left); wood-debris obstructed all surface visibility (right).

The parcel has been cleared for logging at least twice in its history. One episode likely occurred during the Historic era, based on the 1936 Metsker map (see Figure 6) showing it as mill property and a notched tree stump observed after vegetation removal (Photo 3). The parcel was again logged and mechanically cleared of vegetation sometime around 2005, when a grading permit was obtained prior to planned development of the parcel that never actually took place (see Figures 2 and 3). Logging slash was bulldozed into centrally located piles at this time, which is noted in the Wetland Resources “Critical Area Study and Wetland Mitigation Plan for Interair Commerce Center” (2011); logging slash was also observed during the archaeological survey (Photo 4). After the 2005 clearing of the parcel, vegetation was allowed to grow back. The area is now completely covered in dense young alder, blackberries, and salmonberry. Vegetation was so dense that, except along existing trails, penetration for our testing purposes was impossible without the aid of mechanical removal (Photo 5; see Photos 1–4). The proponent therefore used a mechanical excavator to clear vegetation from a portion of the parcel on May 27th and 28th. A permit for this work was obtained from the City of Everett. No grading or excavating was conducted, with the exception of the soil testing discussed below. All vegetation removal and the excavation of soil test pits was observed by a Tierra archaeologist, with negative results.

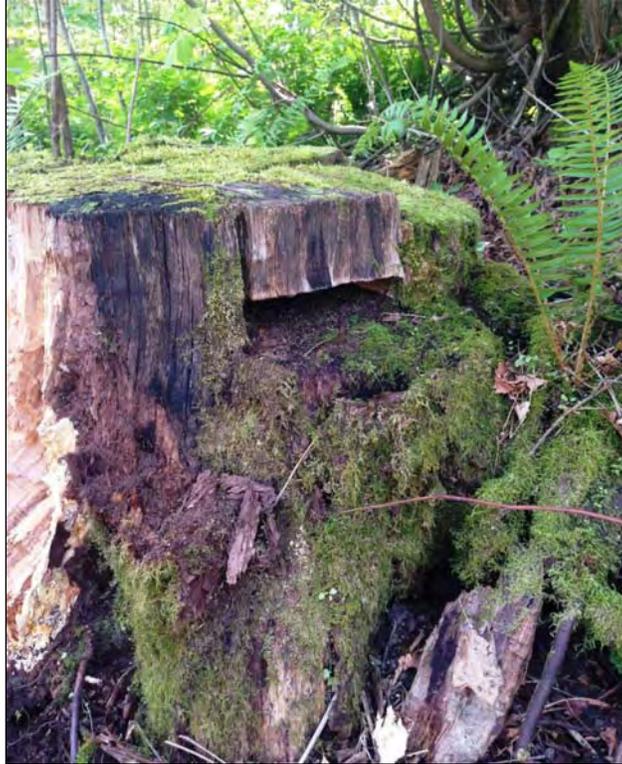
Photo 3. Notched tree stump observed on site following vegetation removal.

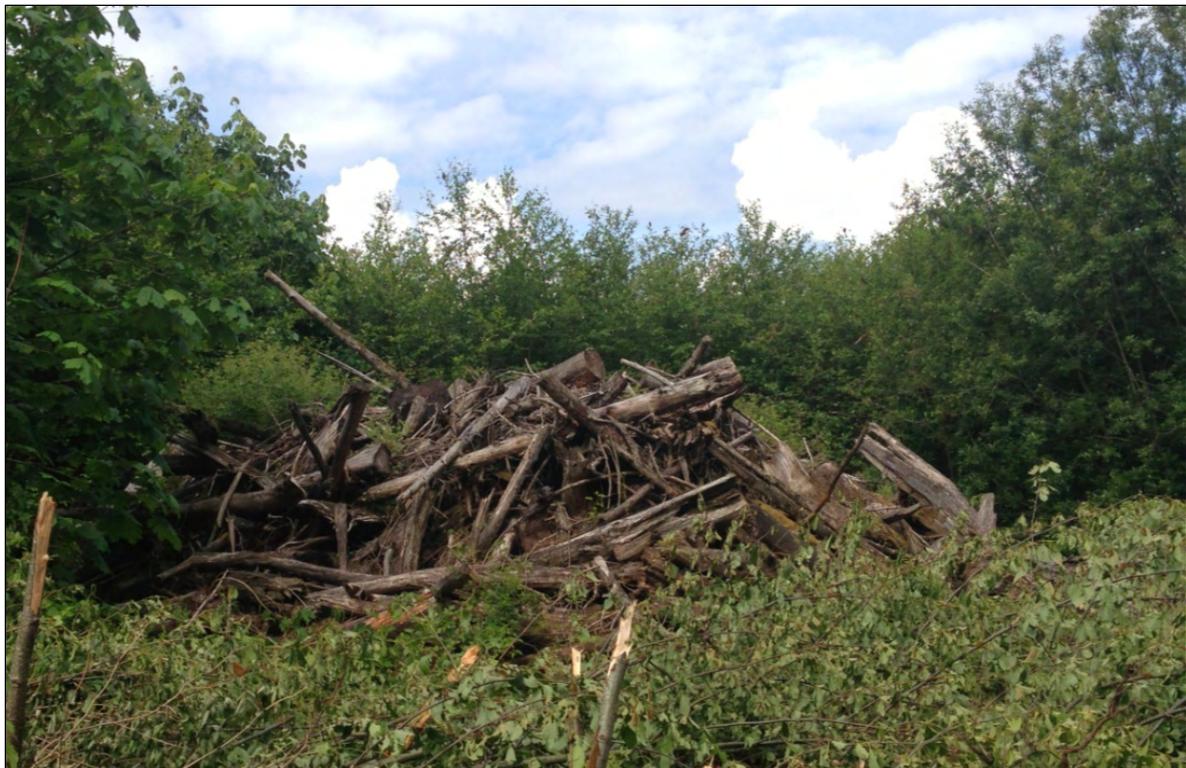
Photo 4. Logged slash in piles. View is to the west.

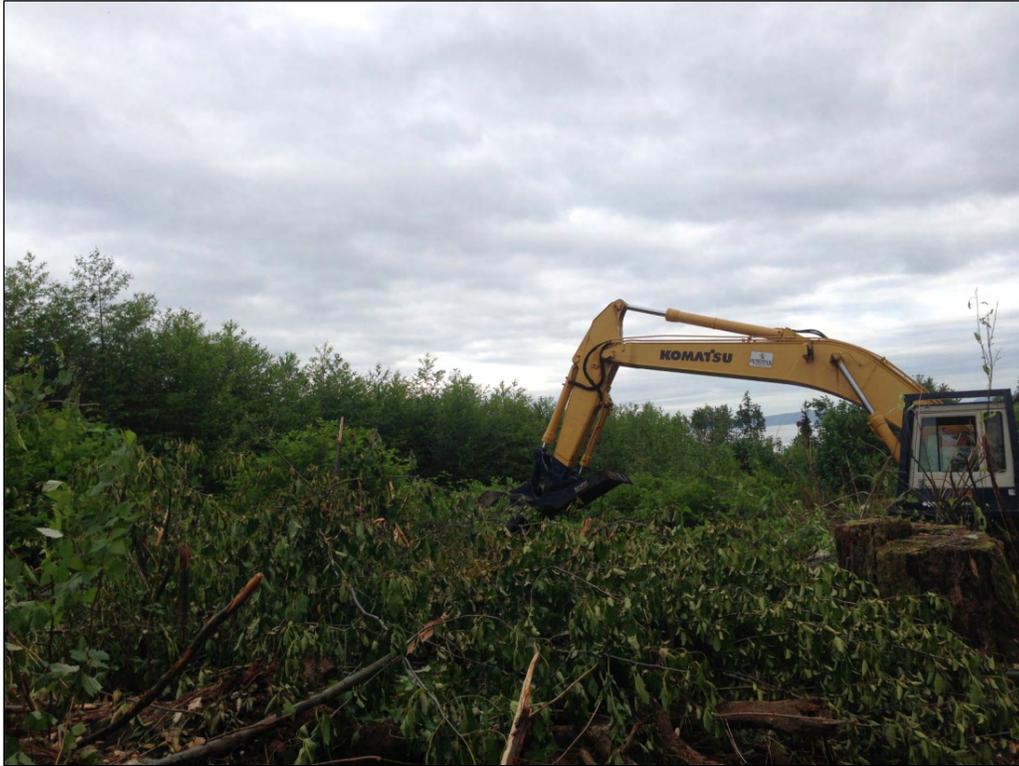
Photo 5. Mechanized vegetation removal.

This strata suggested clear mixing of surface soil with glacial till material, indicating past disturbance that was probably associated with logging, grubbing, stump removal, and bulldozing activities either in 2005 or perhaps earlier. Testing on May 27th and 28th consisted of the excavation of seven additional STPs (STPs 15–21) and four soil test pits (SPs 1–4), along the mechanically cleared path west and north of the testing performed earlier in the month. The SPs revealed the same forest soil A horizon over a mixed and disturbed B horizon consisting of orange-brown sandy silt loam containing charcoal bits, wood, and roots among typical glacially deposited rounded and subrounded cobbles and gravels (Photos 6–11). The olive-to-gray glacial till was observed in all the STPs and SPs at depth. No artifacts, features, or other cultural indicators were observed in the soil test pits, shovel probes, walls, or backdirt.

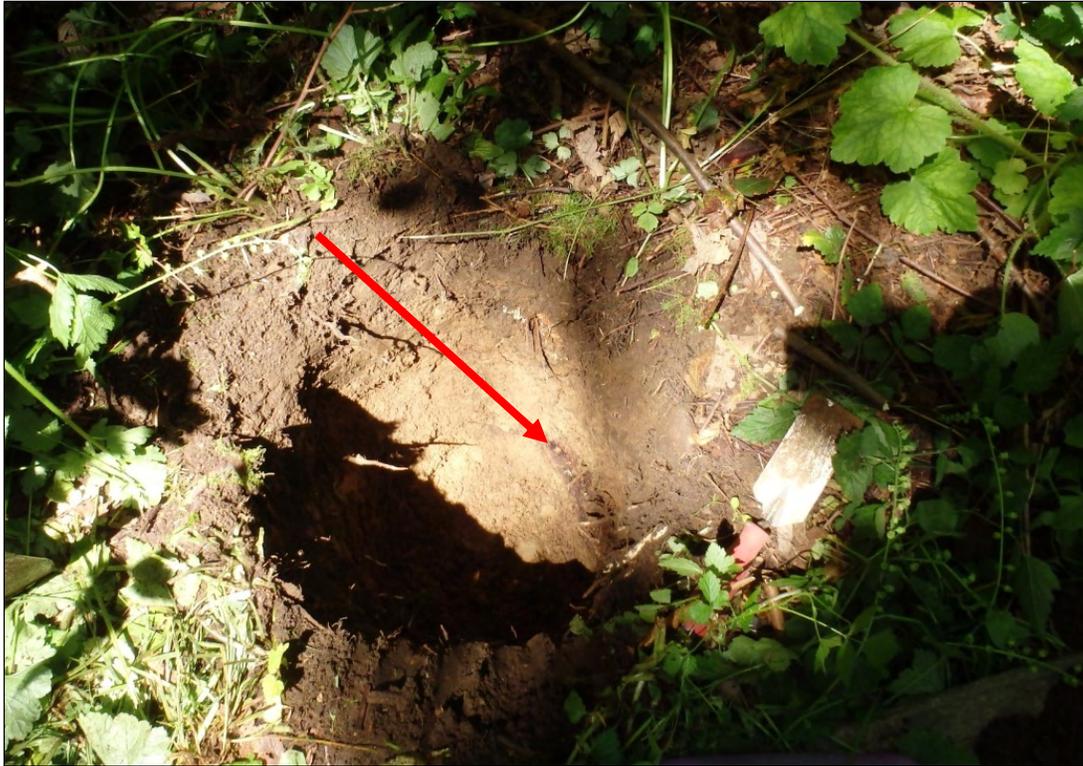
Photo 6. STP 8, northwest profile; arrow pointing to burned or rotting wood/root in north wall.

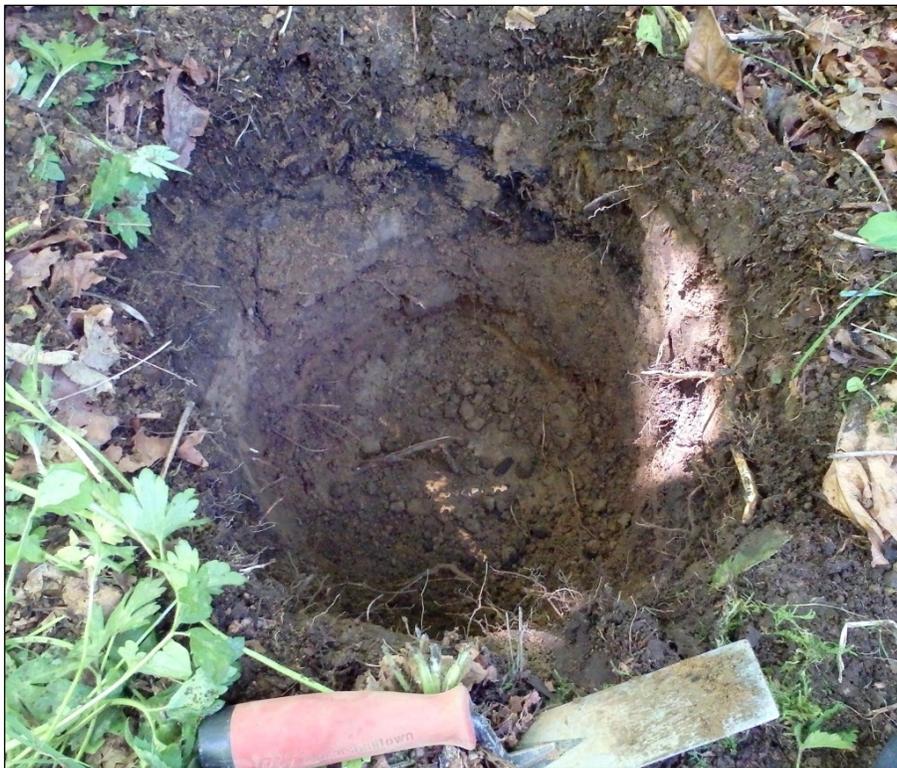
Photo 7. STP 12, view of west profile with charcoal at 6–34 cm (2–13 inches) below surface, with the three soil horizons seen throughout the site.

In roughly half of the STPs a third strata was evident; it was found either between the A horizon and the glacial deposits or it replaced the forest soil entirely. This layer consisted of a brown sandy silt loam containing organics including charcoal bits, charred roots, and woody debris with cobbles and gravels (see Photos 3–5).

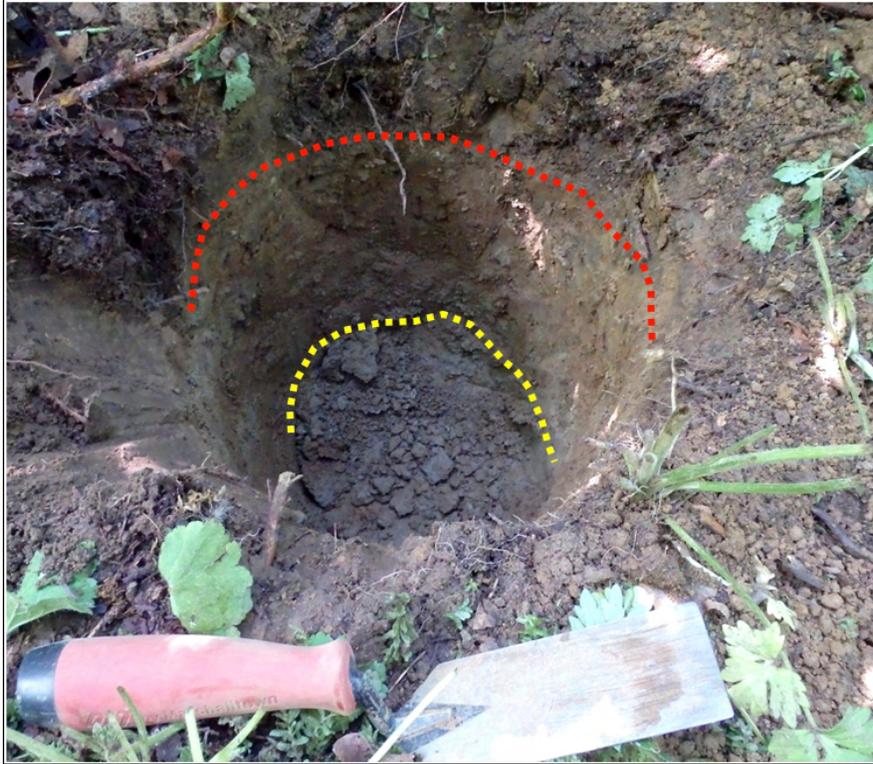
Photo 8. STP 13, west profile showing the three soil horizons observed at the site.
